Surveys of Abandoned Vessels:

Guam and CNMI

**SURVEYS OF ABANDONED VESSELS:
GUAM AND THE COMMONWEALTH OF THE NORTHERN MARIANA ISLANDS**

October 2003

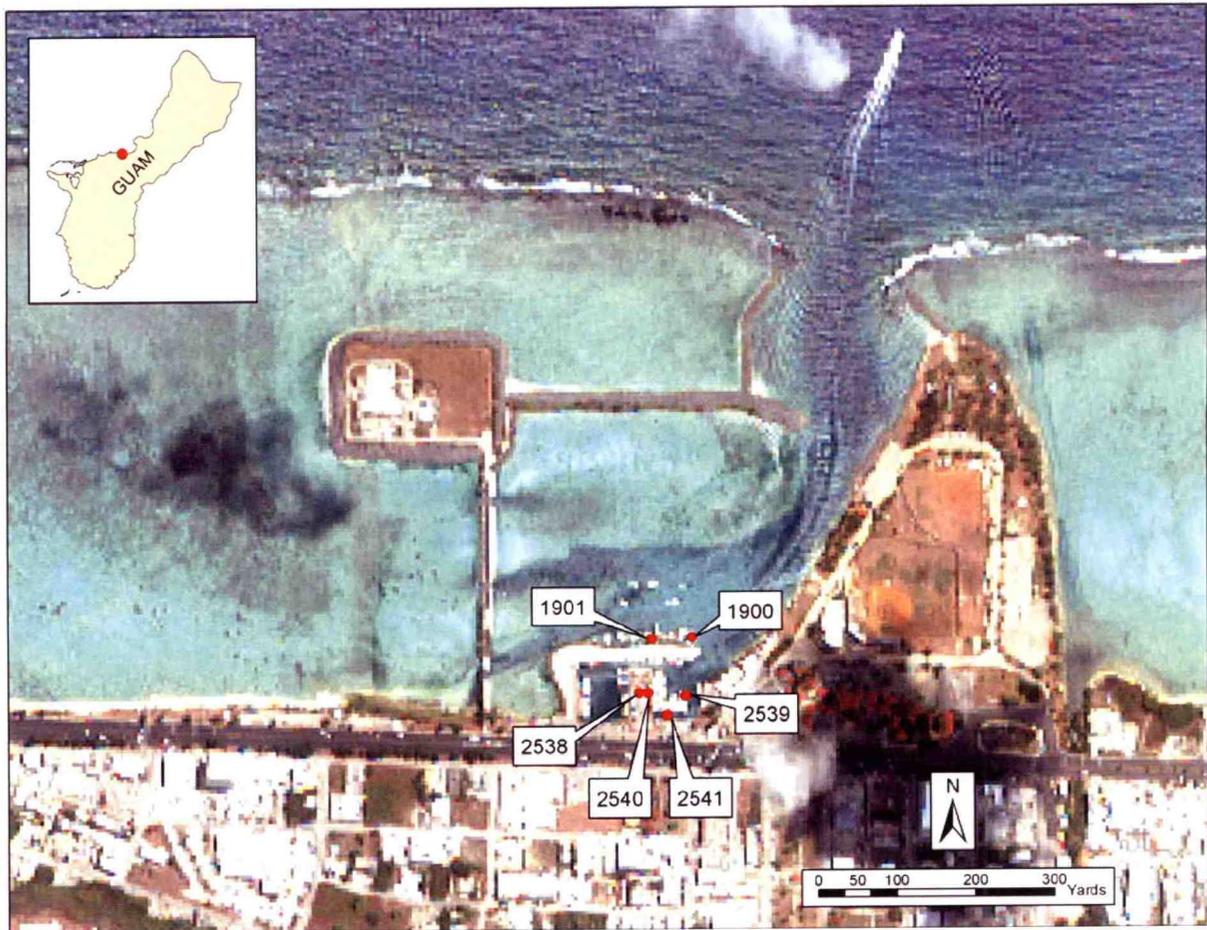
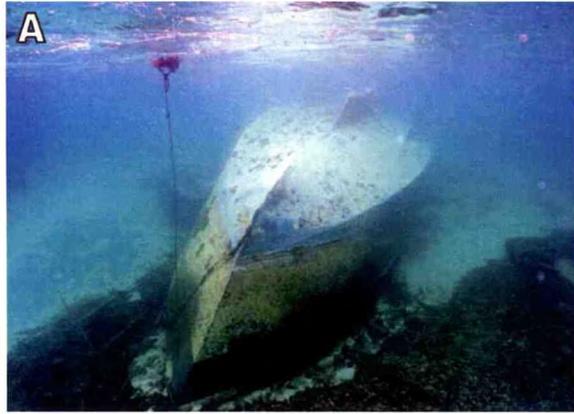
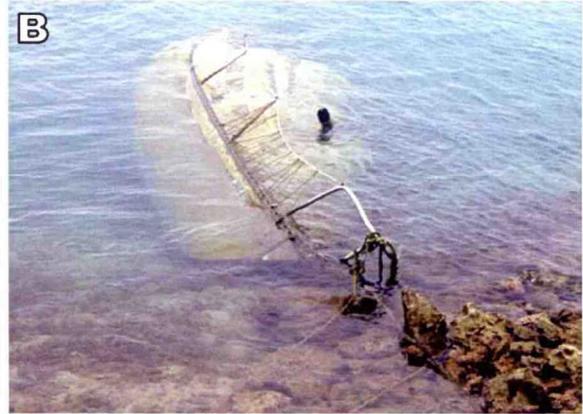
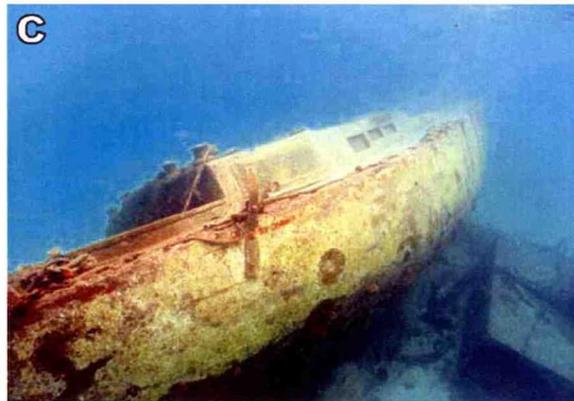
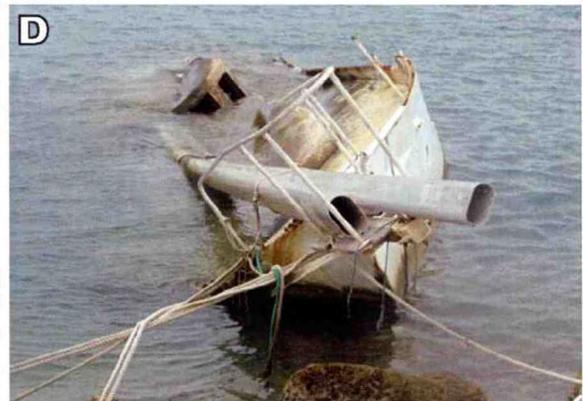
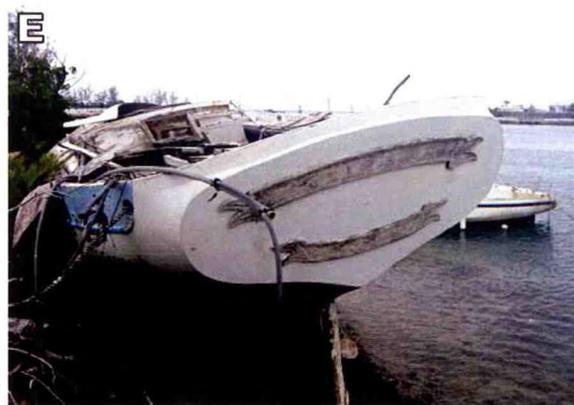
PLATE 10. Agana Boat Basin, Guam.

Comparison to Other Vessels: These vessels are in one of the tighter “clusters” found in the survey. One of these vessels (*Lion’s Den*, Incident ID: 1901) is a pollution threat and one (Unk1900) is a threat to navigation. These vessels could also threaten other vessels moored in the area if they were to move in a storm. Vessels clustered in mooring areas following hurricanes were also common in the U.S. Caribbean.

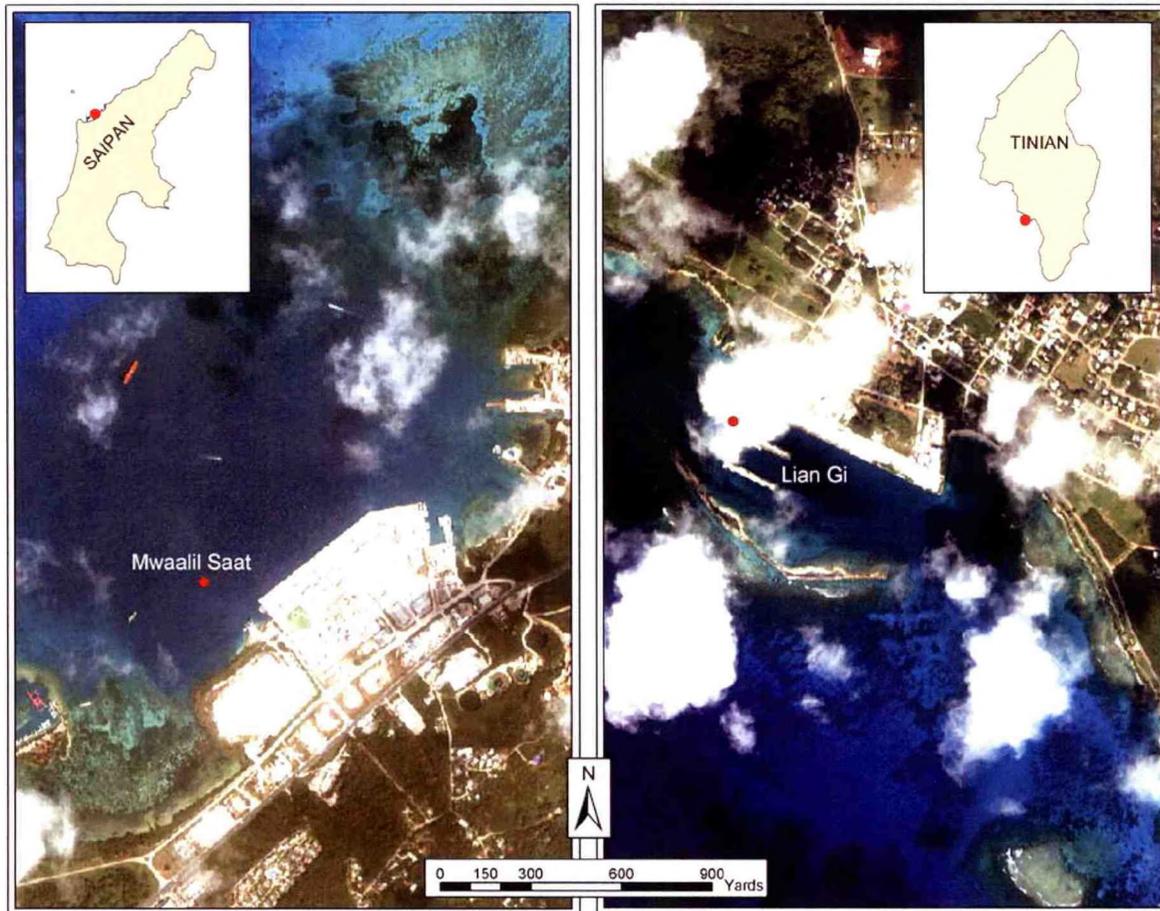
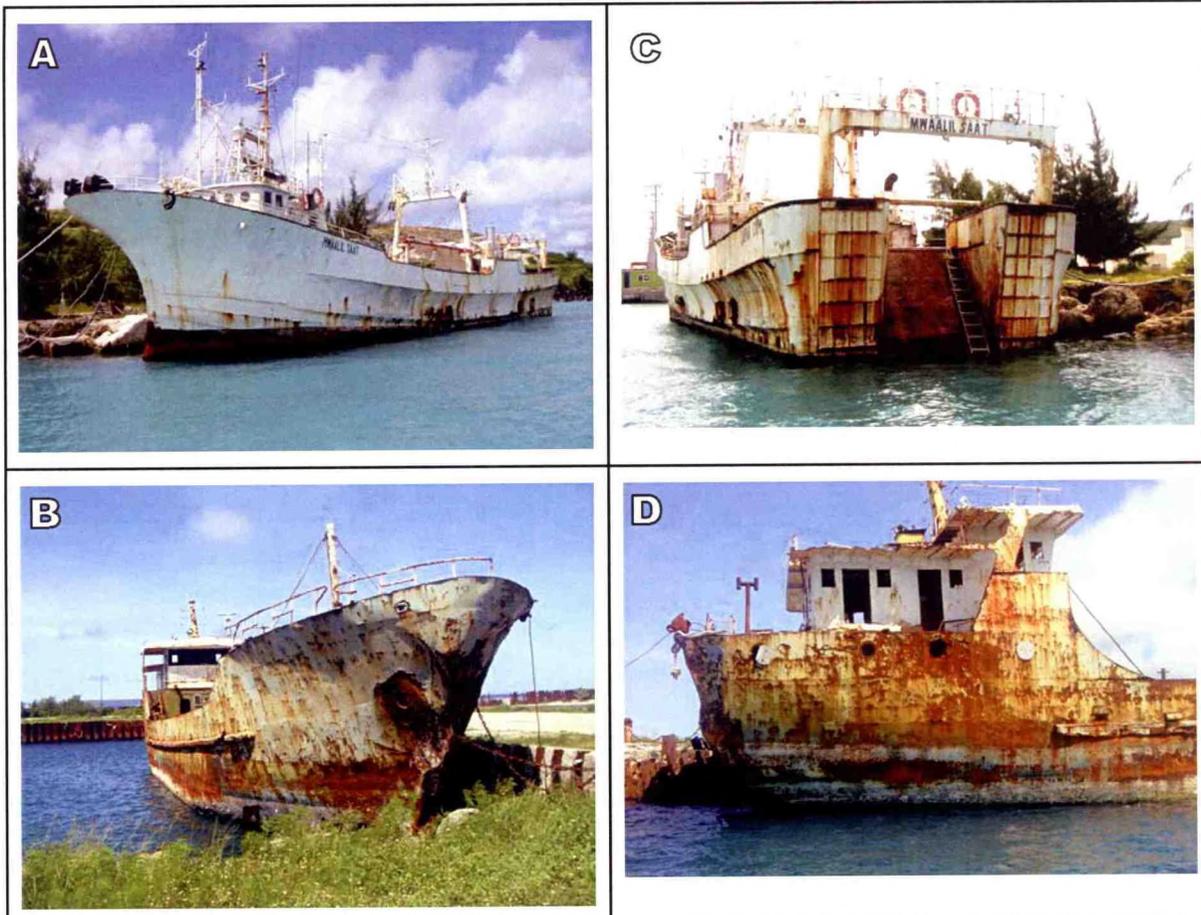
PLATE 11. *Mwaalil Saat* (Incident ID: 2546) and *Lian Gi* (Incident ID: 2577).

Comparison to Other Vessels/Removal Considerations: Each of these vessels is of note because they are pollution and health risks that can be eliminated prior to grounding or sinking. Vessels such as these are in their last relatively easily manageable stage before becoming a much more logistically complex salvage and recovery project.
